Teeth Removal Scheme Explained

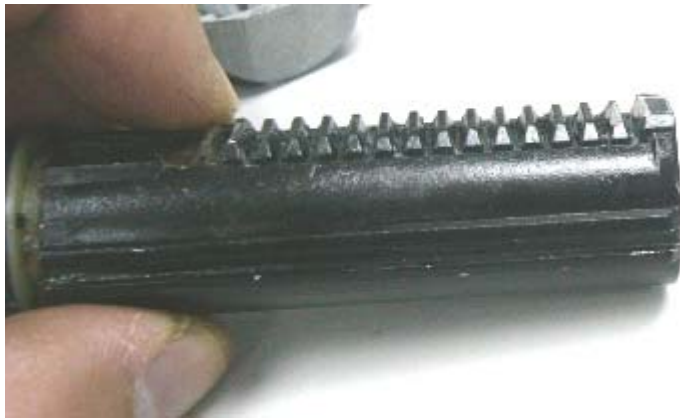
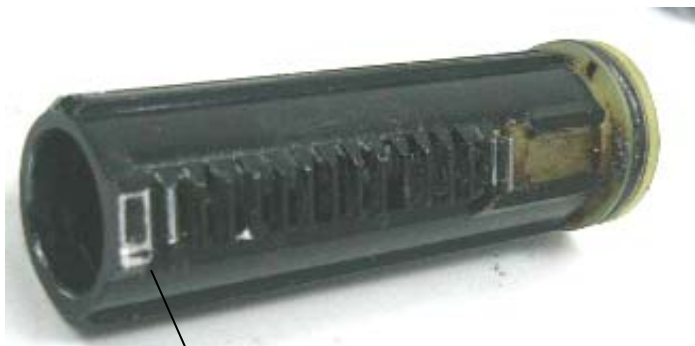
Problem here could indicate that this particular tooth of this particular model of piston was made too thick (a design or manufacturing problem), OR the piston head installed was too thick for it (a configuration problem).

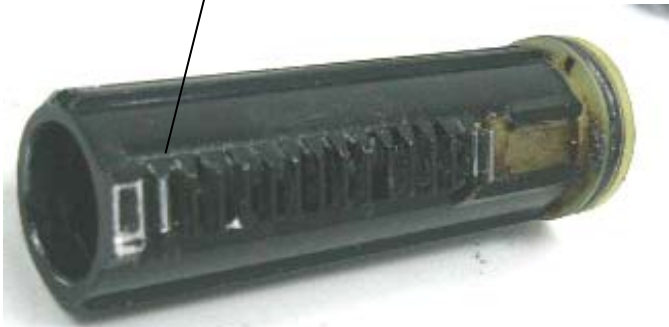
Problem on the first tooth slows things down, so this second tooth was affected (got hit by the sector gear teeth).

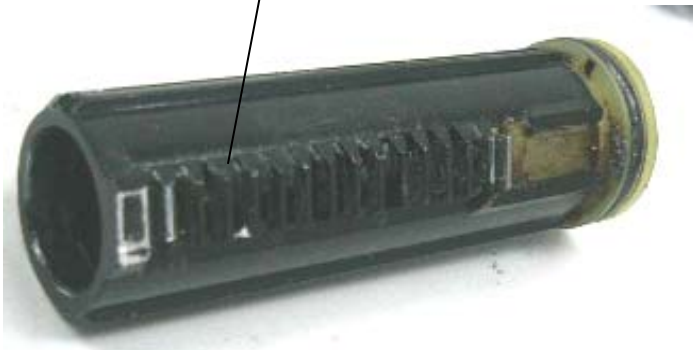
If you are going high ROF, the already slowed piston movement would become even “slower” in a relative sense. Therefore the third and the fourth tooth could get affected as well.

Determining the actual tooth to remove really depends on what is happening with your current configuration. Our recommendation aims at providing you with the safest choice in general.
